Innovative Stormwater Solutions for Ohio

Case Studies of LID Implementation and Performance 2015

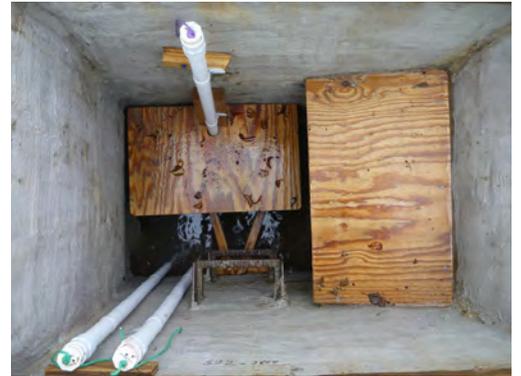
Hydrologic monitoring at Holden Arboretum

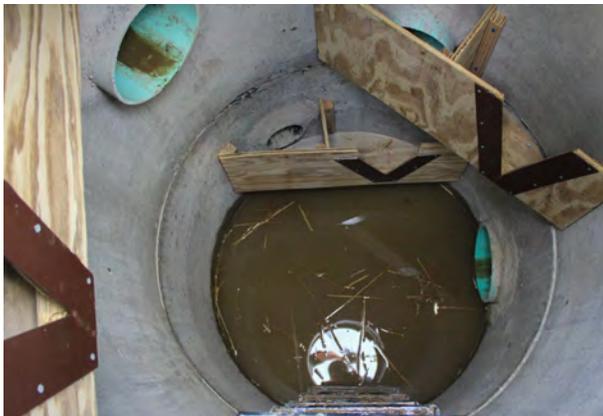
V-notch weirs at Orange Village

V-notch weirs and pressure transducers were used to measure outflow rates. V-notch weirs were chosen because they give the best low flow accuracy. Additionally, pressure transducers were calibrated after every data download to prevent equipment drift. Post-processing was required to translate depth measurements to flow rate using standard weir equations. Water table wells equipped with pressure transducers allowed for continuous depth measurement of subsurface ponding in each SCM to ascertain depth of the internal water storage layer in the aggregate as a function of time and to increase understanding of infiltration at the site. Select project sites were also monitored for water quality, clogging rates of permeable pavement installations, and soil moisture variations in bioretention cells. Temperature measurements were made at all SCMs to determine their capacity to protect coldwater streams that host sensitive fish and macroinvertebrate communities.

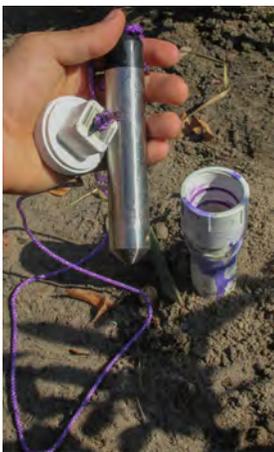
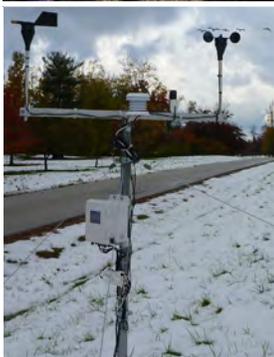
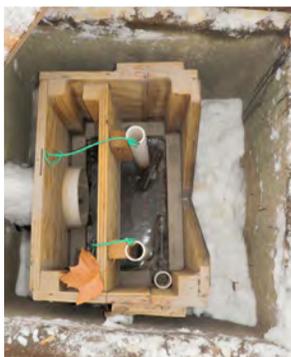
Top Right: Water spills over a weir at Willoughby Hills

Top Left: Water table well at Holden Arboretum

Bottom Right: Pressure transducers frozen inside a weir box at Willoughby Hills

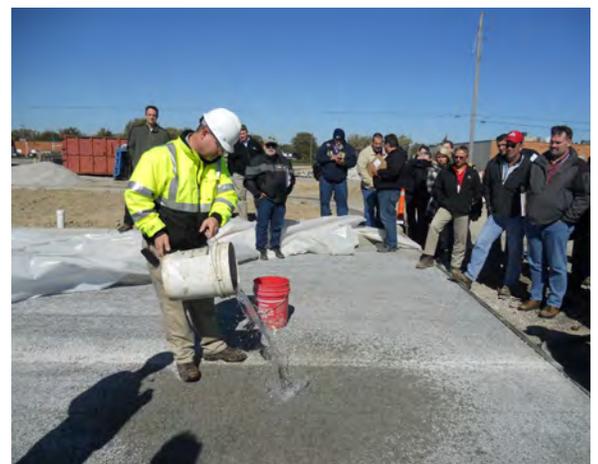
BMP construction workshop at Perkins Township

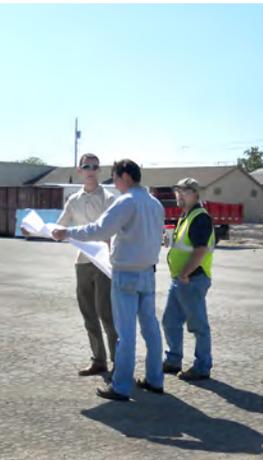
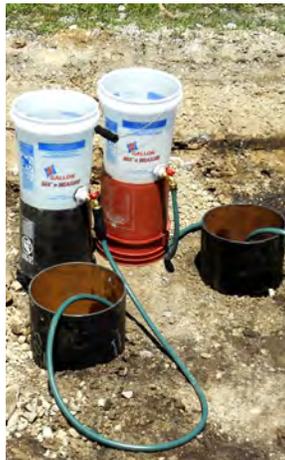
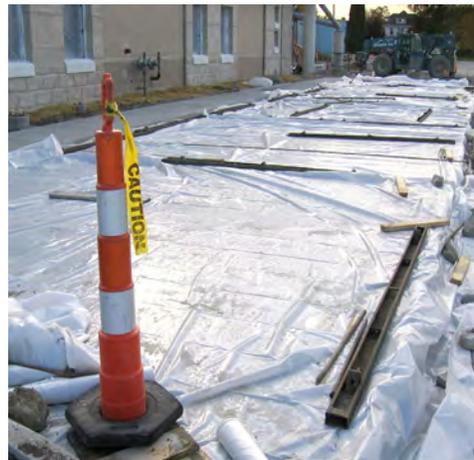
This site was designed such that impervious concrete drive lanes are crowned to drain into adjacent pervious concrete parking bays. Additionally, runoff from the 12,632 square foot roof is piped into the subgrade of the pervious concrete application to the west of the building. The engineers considered the high hydraulic loading ratio acceptable since much of the contributing drainage is cleaner roof top water. To maximize the infiltration potential of this area, the drive lane between the pervious concrete bays to the west of the building is also underlain by 17 inches of #57 stone to add reservoir storage. The cross-section for the pervious concrete bays west of the building consists of 6 inches of pervious concrete, over 2 inches of #8 stone, over 13 inches of #57 stone. The 4 inch diameter underdrains in this western parking area are raised 6 inches above the bottom of the subgrade to create a sump to store and exfiltrate stormwater.

The north and east parking areas that only accept runoff from the drive lanes do not have a sump. In these areas, 6 inches of pervious concrete surface was placed over a 2 inch choker course of #8 stone over an 8 inch subbase of #57 stone. Four inch diameter underdrains run along the face of the curb line on top of the nonwoven geotextile filter fabric at the soil interface. Drive aisles are standard impervious concrete surface with no reservoir beneath them.

For all pervious concrete applications on the site, the subgrades are level to allow water to pond evenly. Since the underdrains for the pervious concrete had very little slope, the design engineers added multiple clean-outs.

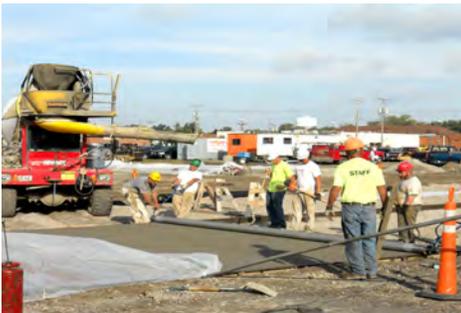
The Township hired RMH Concrete, a certified pervious concrete installer, for this project. The subgrade of the northern and eastern parking areas was not scarified prior to placement of geotextile fabric and stone, but the subgrade of the western area was scarified. The washed limestone aggregate was compacted with machine traffic during placement of the stone. Further compaction was unnecessary because of the absence of fines. Pervious concrete was placed into forms and rolled by hand to achieve the desired grade and structural density. The construction crew prevented drying during the initial installation by using sprayers and rollers to moisten and mold the surface.

Immediately after grading and rolling, the pervious concrete was covered with plastic to facilitate proper curing and protect it from rapid drying. Pervious concrete must be covered with plastic sheeting within 10-12 minutes of placement and must stay completely covered for a week. The crew had some difficulty working with the concrete in areas adjacent to curbs, and ultimately weather became the most significant challenge. Strong winds removed plastic covering and exposed a section of the curing concrete during the initial 10 day curing process. This resulted in some surface raveling. The structural integrity of the uncovered pervious concrete section appears to be sound, but this section is not as aesthetically pleasing as the other pervious concrete areas.

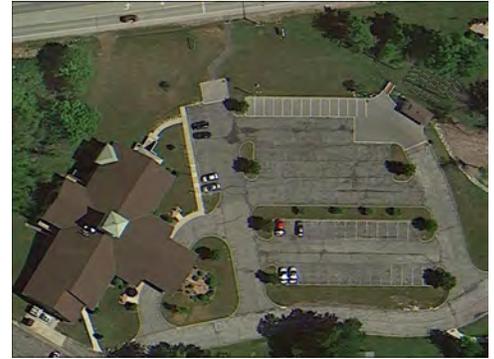
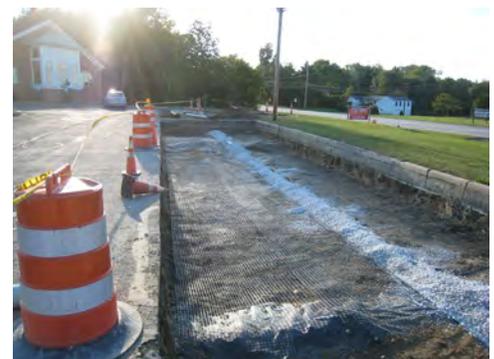
The total aggregate depth was 19.5 inches, with 1.5 inches of #8 bedding stone immediately below the pavers, 6 inches of #57 aggregate beneath that, and 12 inches of #1/#2 aggregate serving as a base course. An upturned elbow on the 6 inch PVC underdrain created a 6 inch sump to

A design challenge at this site was that the west side of the large permeable paver bay was higher than the east side. In order to promote infiltration, the subgrade at the interface of the aggregate and the soil needs to be level. To minimize excavation costs while still promoting infiltration, the engineers chose to create 4 terraces in the subgrade. Plastic wrapped soil baffles pond water on each terrace.

Construction was performed by a single contractor. During excavation, heavy machinery traffic over the PICP system subgrade compacted the soil. In an attempt to correct this, the operator scarified the underlying soil using the teeth of the excavator bucket to loosen the soil. Next, the underdrains were installed and connected to the existing catch basins. A Tensar BX1200 Geogrid was laid down on subgrade, the water table wells were installed, and the excavated area was filled with a mixture of clean #1 and #2 limestone as the subbase. This layer was graded and a plate compactor was used to interlock the stone. Installation of the concrete curbs followed and was performed by hand to ensure that

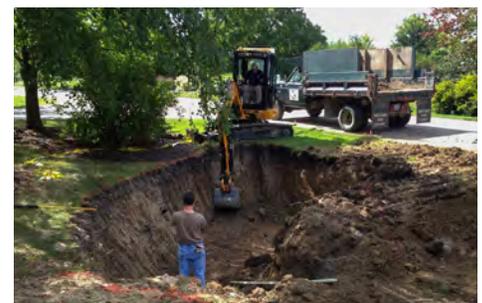
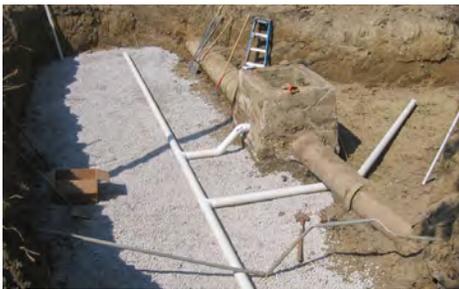
Each bioretention cell was excavated using a small track hoe. During excavation, the team encountered unmarked utilities. They cracked the outlet pipe leading to one of the catch basins, and repaired it with hydraulic cement. An electrical conduit for a lamppost was also damaged but was repaired as well.

A skid steer delivered layers of gravel and sand. Each layer was spread out and leveled by hand using rakes and shovels. The bottom layer consisted of 12 inches of washed #57 angular gravel to provide drainage and bedding for the underdrain. Installation of the underdrains required modification of the catch basins. Holden Arboretum staff drilled new outlet holes, installed PVC pipe outlets, and then sealed each outlet with hydraulic cement. Next, a filter layer was installed that consisted of 3 inches of medium concrete sand on top of 3 inches of #78 gravel. The final layer consisted of 36 inches of bioretention soil mix. Due to a miscommunication, the height of the catch basins were raised to a height of 15 inches above the filter beds instead of the 12 inch design specified. However, since these sites were closely monitored, it was decided to leave the overflows at the higher elevation to see how the systems perform with the deeper surface ponding.

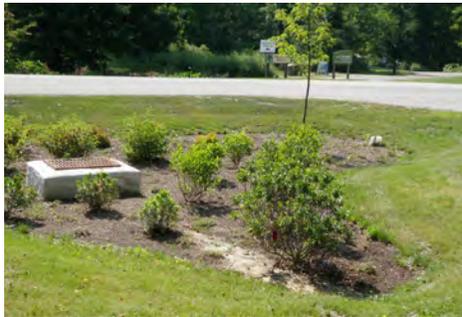
After a heavy storm shortly after construction before the cells were planted, some minor erosion occurred. This demonstrates the importance of site stabilization during or immediately following construction. Use of grass sod on side slopes and on pretreatment filter strips can help to combat erosion in areas with concentrated flow.

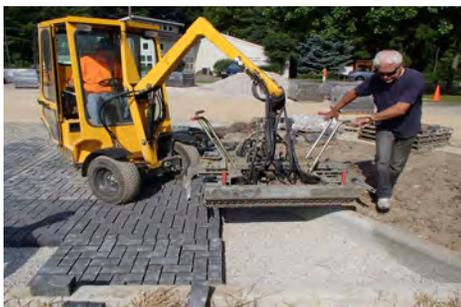
The weight of the cisterns (18,100 lbs) exceeded the 10K limit of an excavator, which required a crane for installation. Crane rental increased the total project cost more than if an excavator was used. If cisterns made from lighter weight material are available, they may be able to be installed with a track hoe saving the cost of crane rental; however, a lighter cistern could float in areas with high water tables. After cistern installation, a fork lift lowered the catch basin into place followed by the pouring and forming of the concrete curbing. Next, a #57 limestone layer and a screeded layer of #78 limestone were installed. Each limestone layer was compacted in 6 inch lifts using a 10 ton roller.

Grey pavers were placed using a robotic paver laying machine. Pavers placed near curbing were adjusted and strategically cut with a saw to ensure correct interlocking alignment. Lines of grey PICP were removed and replaced with red pavers to delineate parking stalls. Next, a brush tool attachment for the robotic paver laying machine was used to sweep #78 limestone into PICP joints. This brush tool also could be used to sweep #78 limestone back into paver joints during maintenance. Additionally, the swale was slightly rerouted, re-graded for positive flow, seeded with an Ohio Department of Transportation seed mix

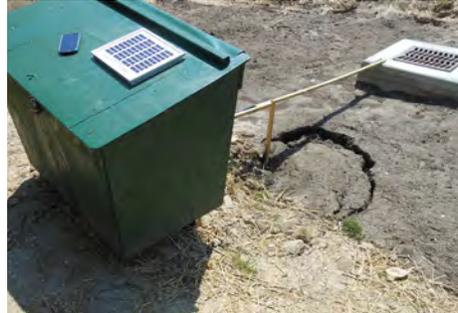
After construction was completed, a large sink hole formed over the new outlet pipe within bioretention cell. Formation of the

sink hole was caused by material settling. The sink hole was addressed by the primary contractor who filled it in. Careful observation of the cell after construction allowed corrective actions to take place

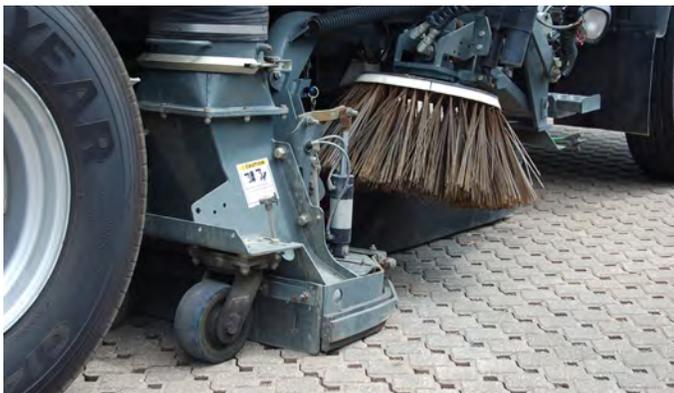
Vacuum sweeper trucks can be used for permeable pavements
