Mapping the Effects of Long-term Hydrologic Stress, Sea-level Rise, and Hurricane Irma on Coastal Habitats in Southwest Florida

Date: Thursday, July 18, 2019 Time: 3.00 - 4.00 PM (EST)

Mapping the Effects of Long-term Hydrology Stress, Sea-level Rise, and Hurricane Irma on Coastal Habitats in Southwest Florida

This webinar described the use of advanced satellite imagery to map the damage, death, and recovery of mangroves with a time series of images from 2010 to 2018. Dr. Matt McCarthy shared the methods used to map the landscape and evaluate change. Dr. Brita Jessen provided background for the study and discussed the management implications for the reserve and other coastal areas. Matt and Brita have been collaborating on a one year-year catalyst project that has relevance to coastal land managers interested in mapping habitat change.

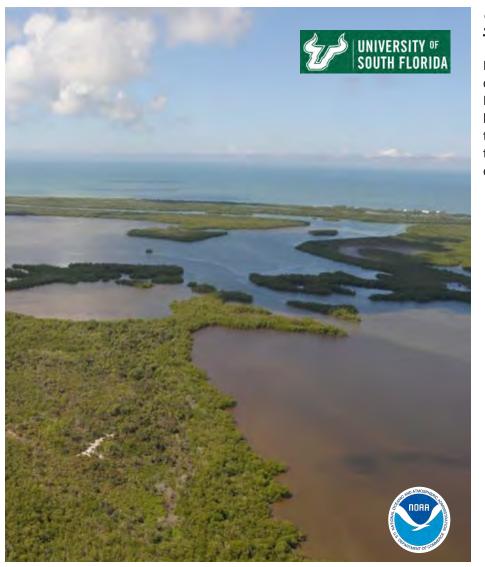
Rookery Bay's coastal fringe habitat is geologically complex and dominated by mangrove vegetation. It is also very flat; inches of elevation change will have a significant impact on habitat types - leading to a mosaic of complex and diverse habitats behind the mangroves - which can be easily altered by environmental drivers.

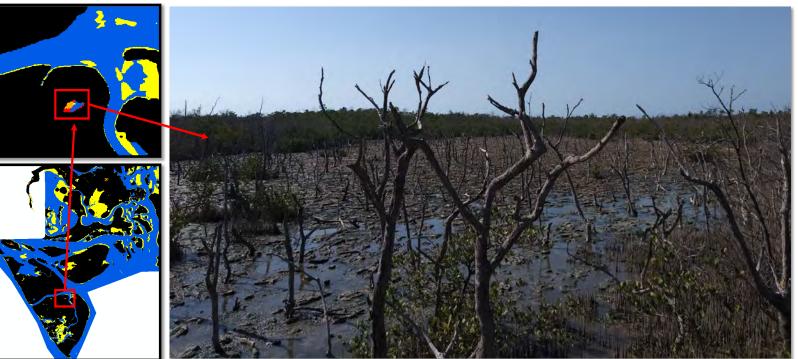
Mangrove Loss

Unusually, one location appeared to have gained water according to the change-detection imaging. The team went into the field and photographed the area, which they found to be a region where black mangroves had died off before Irma. As a result of sea level rise, the relatively lower-lying area - which is still exposed to tidal variations - is retaining more water than it once did, which has slowly killed off the existing black mangroves that once lived there.

From 1966 to 2017, sea levels rose at a mean rate of 3 mm per year, in agreement with the global long term average. From 2000 to 2017, that rate increased to 7 mm per year. From 2010 to 2017, the rate increased to 13 mm per year. Rapid and accelerating sea level rise in this area is affecting inland areas and compounding effects from Hurricane Irma.

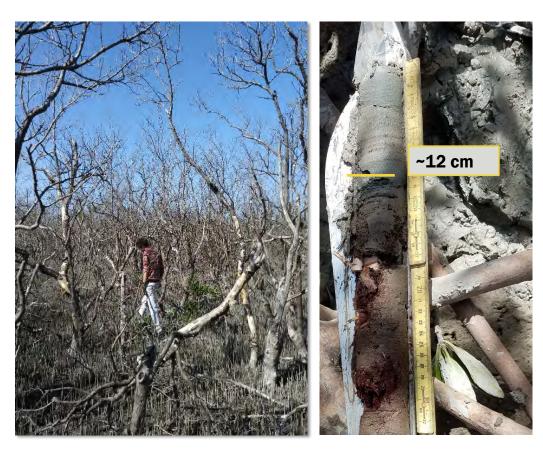
Acute Drivers of Loss

Marl overwash starving mangroves

- Radabaugh et al. 2019
 - 11% mortality 2-3 months post-Irma
 - 20% mortality 9 months post-Irma

The team used change detection results to evaluate drivers of loss. Some of the results of the mangrove dieoff corroborate results from a 2019 study by <u>Radabaugh</u> <u>et al</u>, which found that the mortality of mangroves increased from 11 to 20 percent following Irma. The authors posited that a measured 10+ centimeters of marl overwash caused the delayed loss. Marl overwash, brought up from the bottom of local waterways onto mangrove roots by hurricane storm surge, starved the mangroves of oxygen, and eventually resulted in mortality.

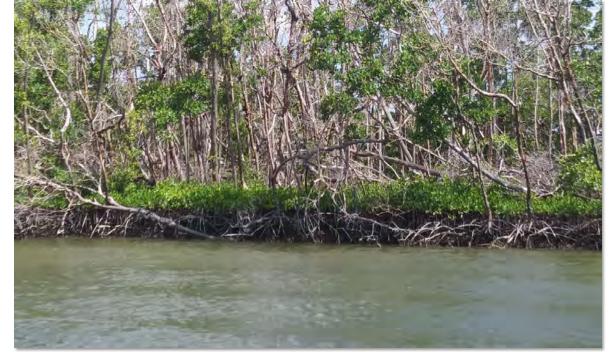
Mangrove Recovery

The team also noted areas of recovery, in which sunlight reached through otherwise thick mangrove canopy, allowing seedlings to grow in areas they otherwise would not have been able to grow if Irma had never degraded existing foliage.

Radabaugh et al. 2019 60% canopy cover 3 to 9 months post-Irma

Sunlight reaching seedlings

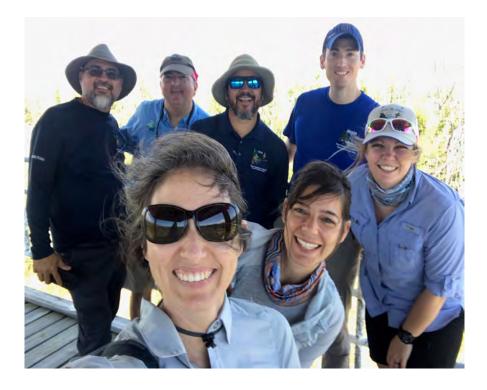
Rookery Bay and South FLORIDA Jobos Bay NERR Capacity Enhancement

- Hurricanes Irma and Maria occurred approximately one week apart
- Scientists and managers conducted crosssite visits to view impacts and recovery
- Stakeholder workshops discussed recovery process, expectations, and needs for informed resource management and information sharing
